New Product Information

TRANSMISSION PAN REPAIR NUT
for 5R55S & 5R55W

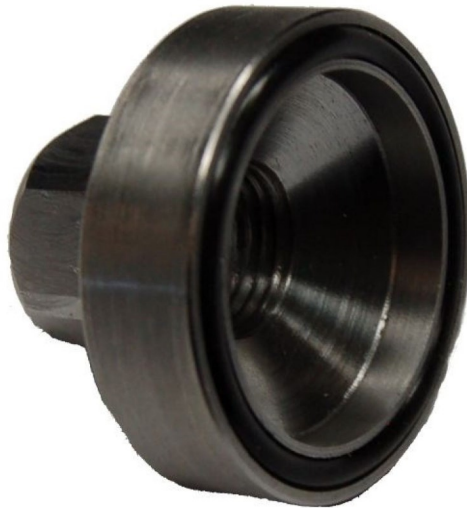
T16494A

When you are removing the filler plug from the bottom of the transmission pan, it can break loose and spin the bradded nut causing leakage.

Use Teckpak-Fitzall **(T16494A)** pan repair nut.

It also saves those pans where the threads are stripped!

NOTE: Mounts inside the transmission pan.
